Wireless Battery-Free Ultrasonic Thickness Measurement Patches for CO₂ Absorber

Martyn Cooper, Principal Integrity Engineer at Santos

VOLUME 27, ISSUE 3

MAY | JUNE 2021

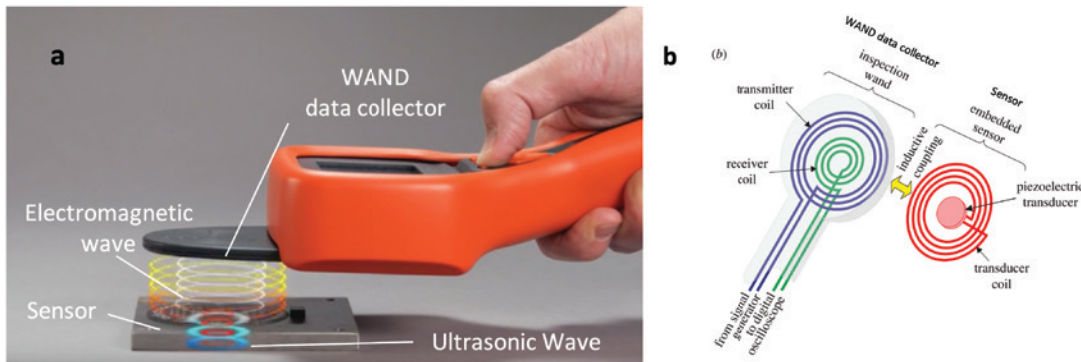
Figure 1. (a) Operation of WAND system, and (b) details of the inductive coupling between the WAND data collector and ultrasonic thickness sensor.

The wireless and nondestructive (WAND) system was initially developed by Zhong et al^[1]. It uses inductive coupling to excite a wireless, battery-free ultrasonic sensor. The sensor is permanently bonded to the structure as illustrated in **Figure 1(a)**. The

inductive coupling is achieved using a three-coil network. One coil, termed the transducer coil, is connected to the piezoelectric transducer. The other two coils, called the transmitting and receiving coils, are contained within the WAND data collector and are connected to the outputs and inputs of the ultrasonic instrumentation as illustrated in **Figure 1(b)**. When the WAND data collector is held in close proximity to the sensor, electrical signals are transferred between the three coils and ultrasonic measurements are recorded from the sensors.

Compared to conventional manual ultrasonic testing, the system enables fast contactless measurements (each reading taking a fraction of a second), with a separation distance between the WAND data collector and sensor in the order of tens of millimeters. In a previous study Zhong et al. showed the system can be used to generate both bulk and guided waves enabling a range of different inspections^[1]. The system has also been successfully used to monitor the curing process and detect damage in composite materials^[2], to monitor the internal corrosion of pipework under composite wrap repairs^[3], and to monitor tidal corrosion on the inside of a wind turbine monopile^[4]. The sensors include an RFID tag that enables readings to be attributed directly to an operator and sensor at acquisition, a key advantage over manual ultrasonic testing methods.

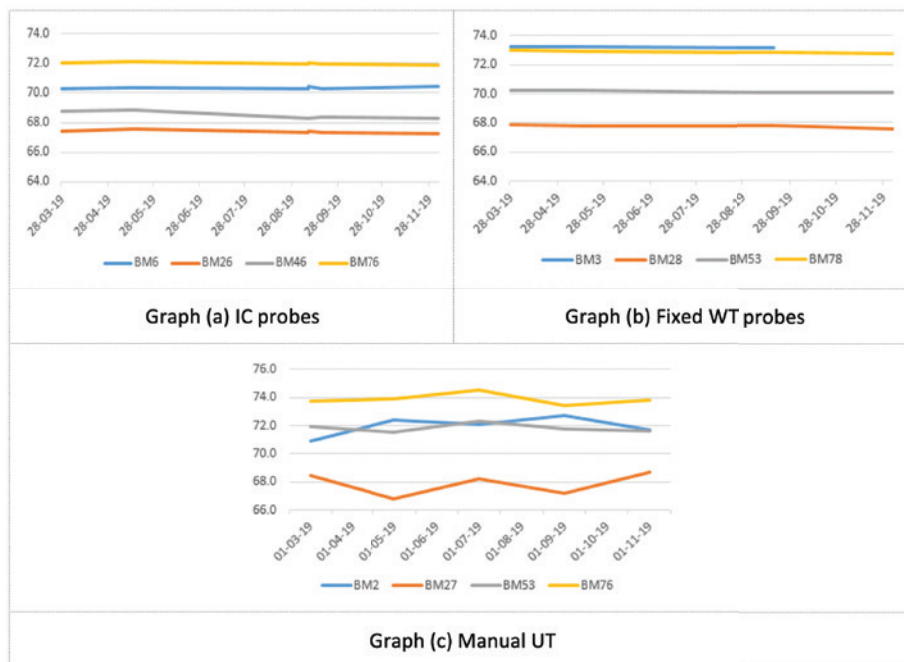
Figure 4. Showing the measured thicknesses. All readings are in mm and the Y-axis scales adjusted to show a 10mm thickness range for comparison purposes. Locations shown refer to the grid reference around the vessel circumference.

The measured corrosion rate is another variable which unsurprisingly demonstrates the benefits of a fixed probe/sensor. The improved accuracy and reduced range between successive readings allow an accurate corrosion rate to be established, something that is not possible with manual readings. **Figure 4** displays the readings taken and clearly shows corrosion loss over time for the fixed probes and sensors, whereas the variability of the manual readings hides any material loss.

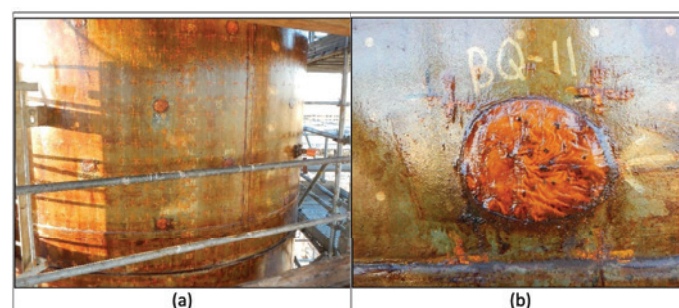
Figure 5. Photographs of sensors after months in service on a “live” plant. (a) Overview of installed sensors and measurement grid with fixed WT probe visible. (b) Detail of sensor BQ11 showing high levels of couplant and poor surface state.

The 50 inductive sensors, IC, were attached to a section of this gridded area in December 2018 at a separation of 500mm to give an even spread around the full circumference. They were read at the same frequency as the manual ultrasonic rope access surveys. An overview of these installations and the measurement grid can be seen in **Figure 5(a)**.

improve accuracy. One of the RFID tags failed after 10 months of operation, but the associated thickness sensor continues to function. The general state of the sensors can be seen in **Figure 5**.
