# APPLICATION NOTE

WAND Sensor Installation at Unpiggable  
Locations Along Natural Gas Pipelines

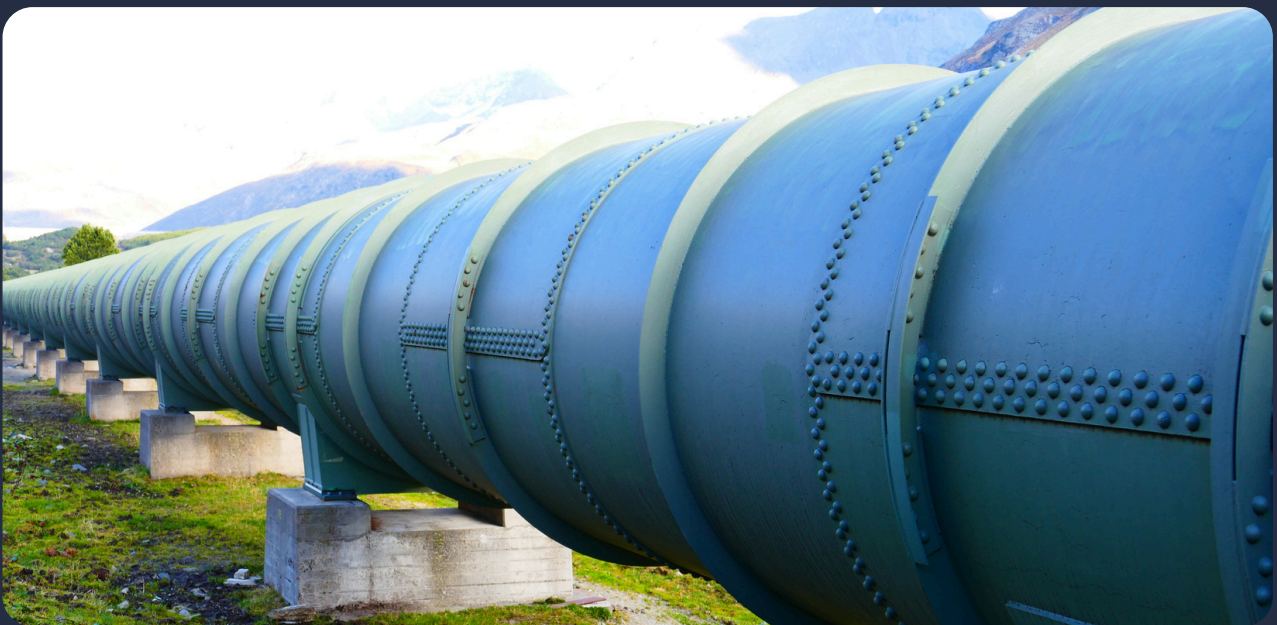
WAND sensors were installed at a number of unpiggable locations along the customer's pipeline. In addition, WAND sensors were installed in 'ring configurations' at various locations as reference thickness values for their intelligent pig. Thickness data was collected easily and quickly by maintenance technicians using the WAND handheld data collector.
