# APPLICATION NOTE

Flare Gas Recovery Unit Corrosion  
Monitoring Using WAND

Refinery Operator

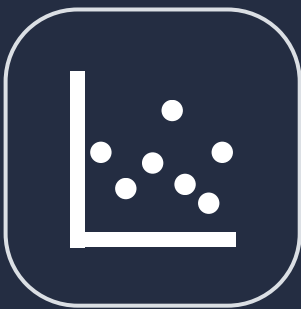
The customer wanted to determine corrosion rate at various locations on the FGRU, in order to assess if corrosion would be exacerbated by changing a certain process condition. Manual UT thickness readings could not be used for this, since poor measurement repeatability could not accurately trend thickness loss for the corrosion rate calculation.

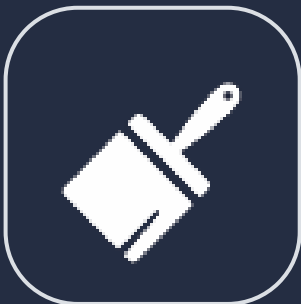
Various measurement locations were underneath coatings, and in order to access them for inspection using manual UT, the coating had to be removed. This was not feasible for the customer, considering the high monitoring frequency.

WAND sensors were installed at designated locations on the FRGU. For those locations underneath coating, the coating was initially removed to install the WAND sensors, and then reapplied on top of the sensors afterward. Data from the sensors was then wirelessly acquired using the WAND handheld data collector.

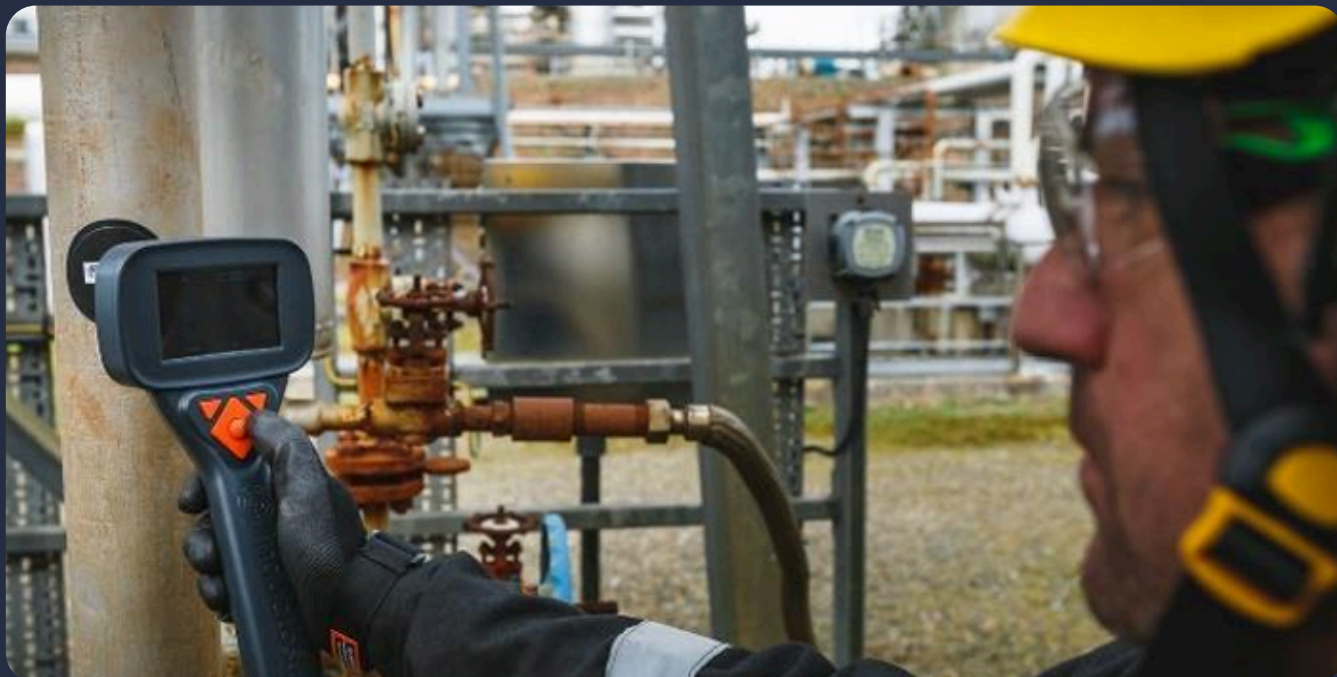
Thickness data from the permanently installed sensors acquired quickly and easily using the WAND handheld data collector.

Thickness data could be wirelessly acquired from the sensors underneath coatings using the WAND handheld data collector, without needing to remove the coating, saving time and costs.
